RDTR NO. 160
3 DECEMBER 1969

SAFETY TEST OF FLARE EXTRUSION FACILITY

**RESEARCH AND DEVELOPMENT DEPARTMENT
NAVAL AMMUNITION DEPOT, CRANE, INDIANA**

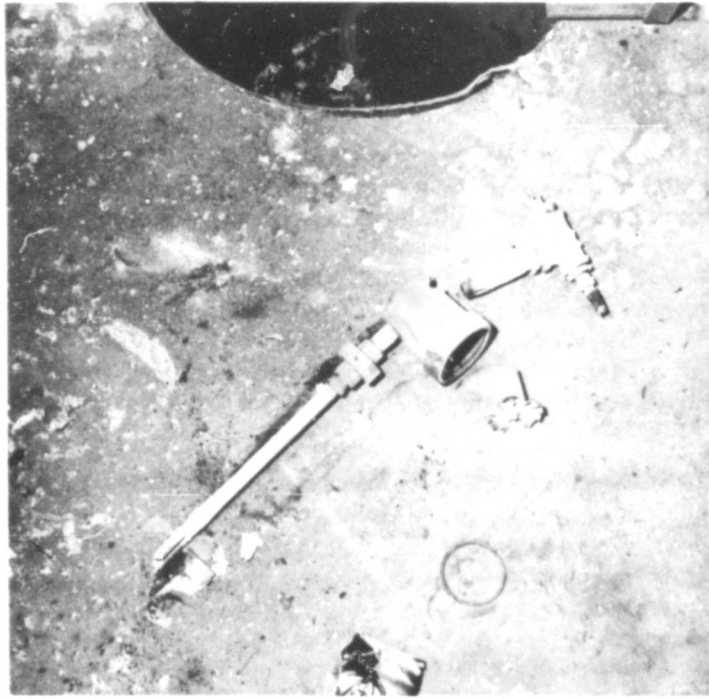
FIGURE 11a PLUMBING FROM TOP OF RAV

3. Burning inside the press was very vigorous and hot, as was expected. A total time of nine seconds of audible burning was indicated by the audio tape. The combustion pressure in the charge cylinder vented in two directions, up through the vacuum passage in the ram and down through the die. Flame venting through the ram melted steel pipe fittings as shown in Figure 11a. These fittings were originally located at the top of the ram--figure 11b. The beryllium copper ram was eroded as shown in figure 12a.

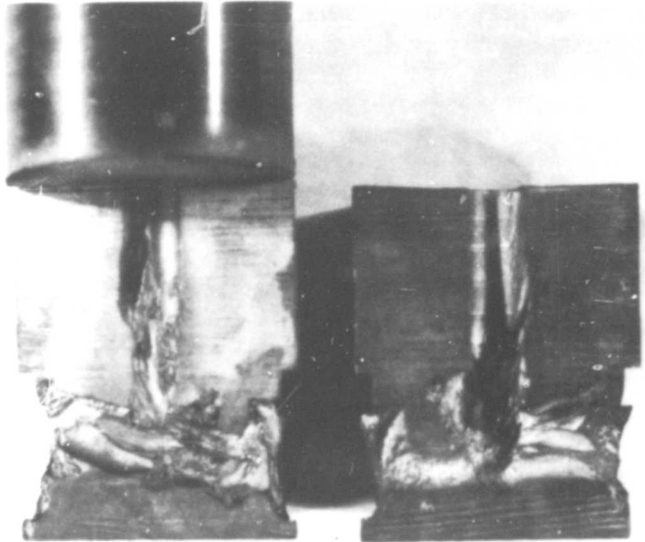
FIGURE 12a RAM EROSION
